AQUATIC LEASE INSPECTION REPORT

LEASE NUMBER: 22-A02332

LESSEE NAME: Bridgeview Marina

DATE OF INSPECTION: 9/18/2014

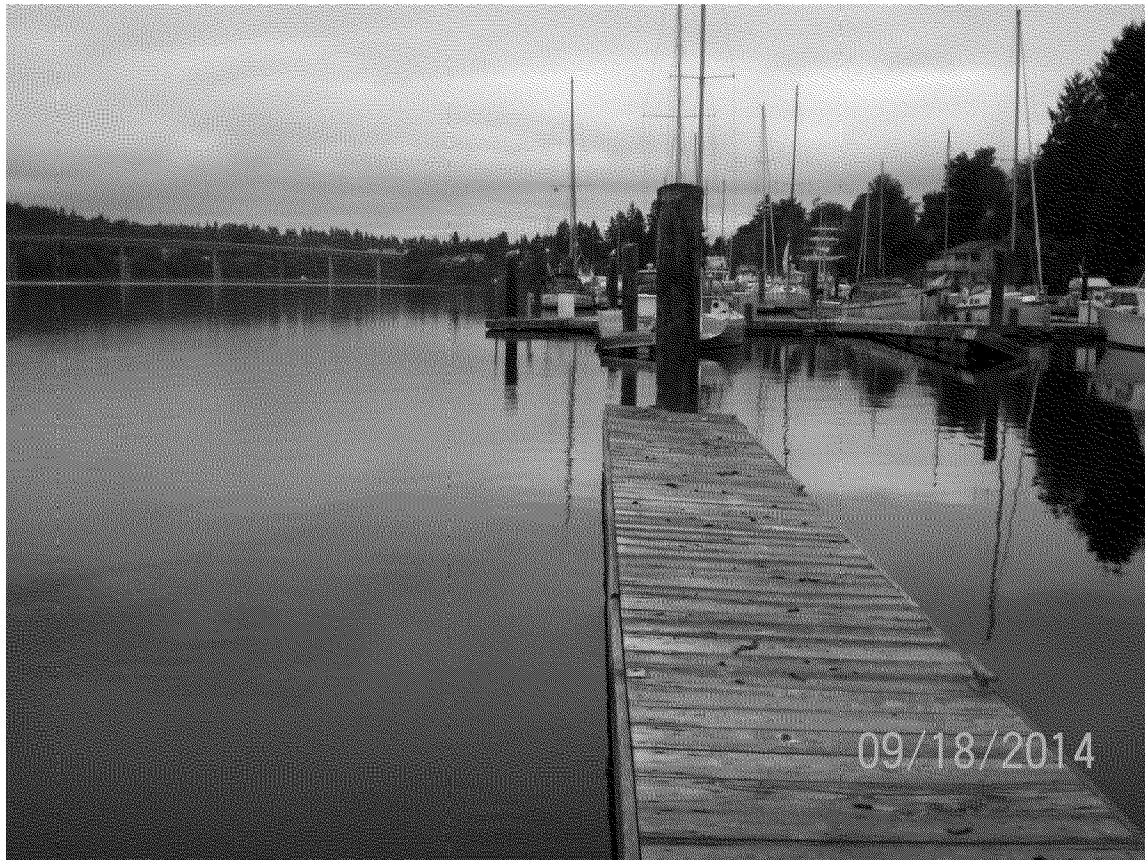
Figure 3: Photo of the end of A Dock. The moorage cleats outside the outer harbor line have been removed.

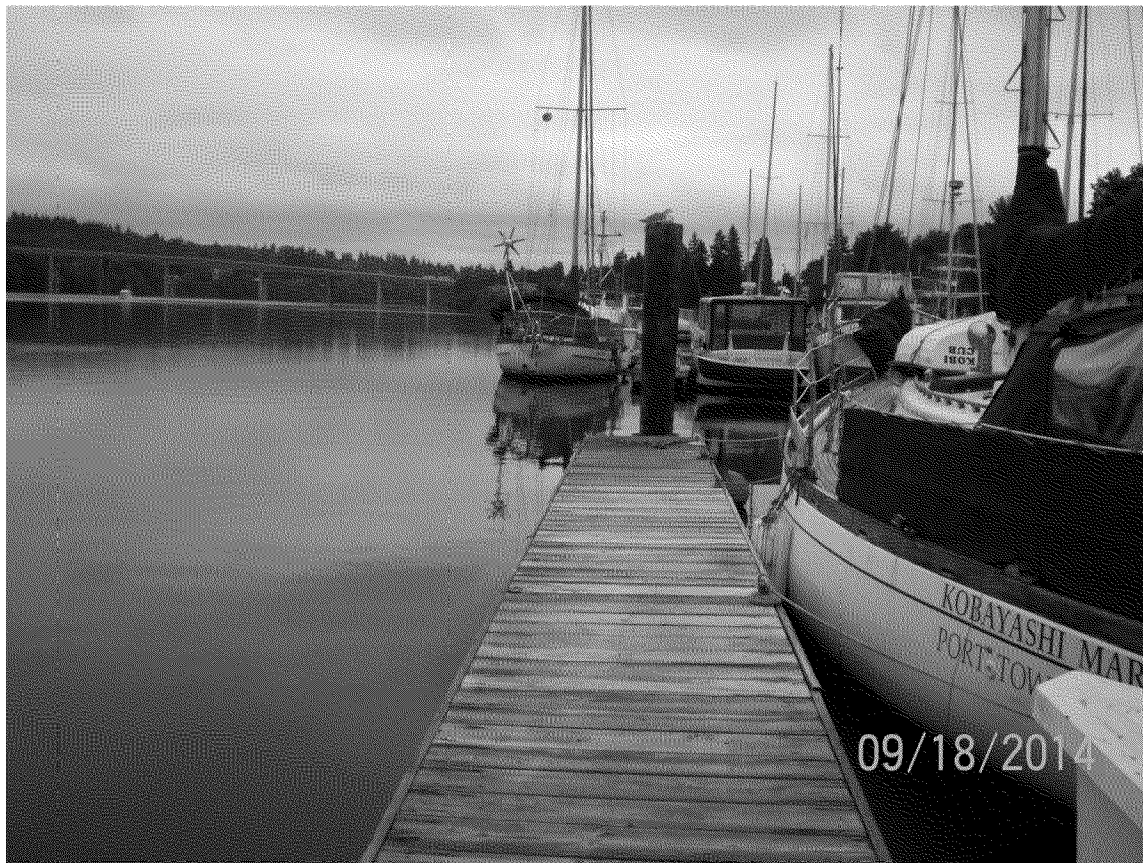
Figure 4: Photo of the end of A dock showing the moorage cleats outside the outer harbor line have been removed.

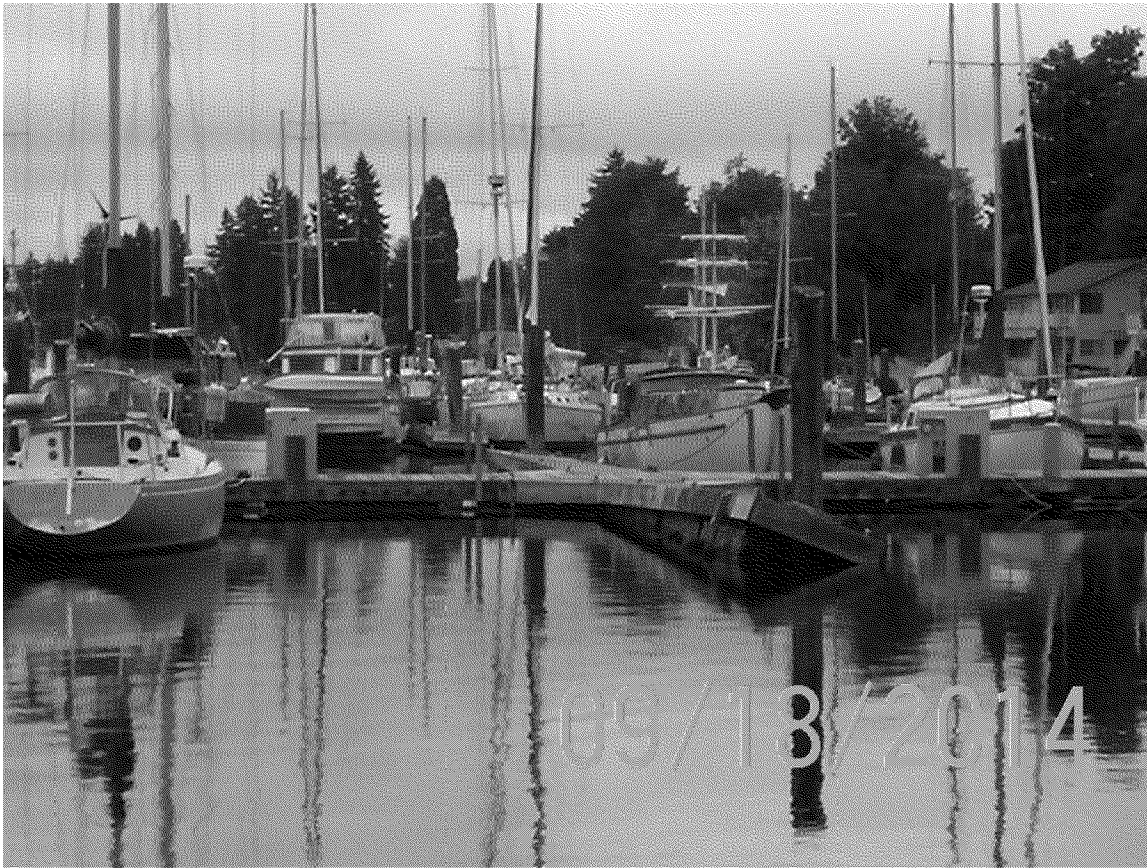
Figure 5: Photo showing the end of B- Dock. The moorage cleats outside the outer harbor line have been removed.
